Debris/Ice/TPS Assessment And Integrated Photographic Analysis For Shuttle Mission STS-49

July 1992

Shuttle Mission STS-49 was launched at 7:40 p.m. local 5/7/92

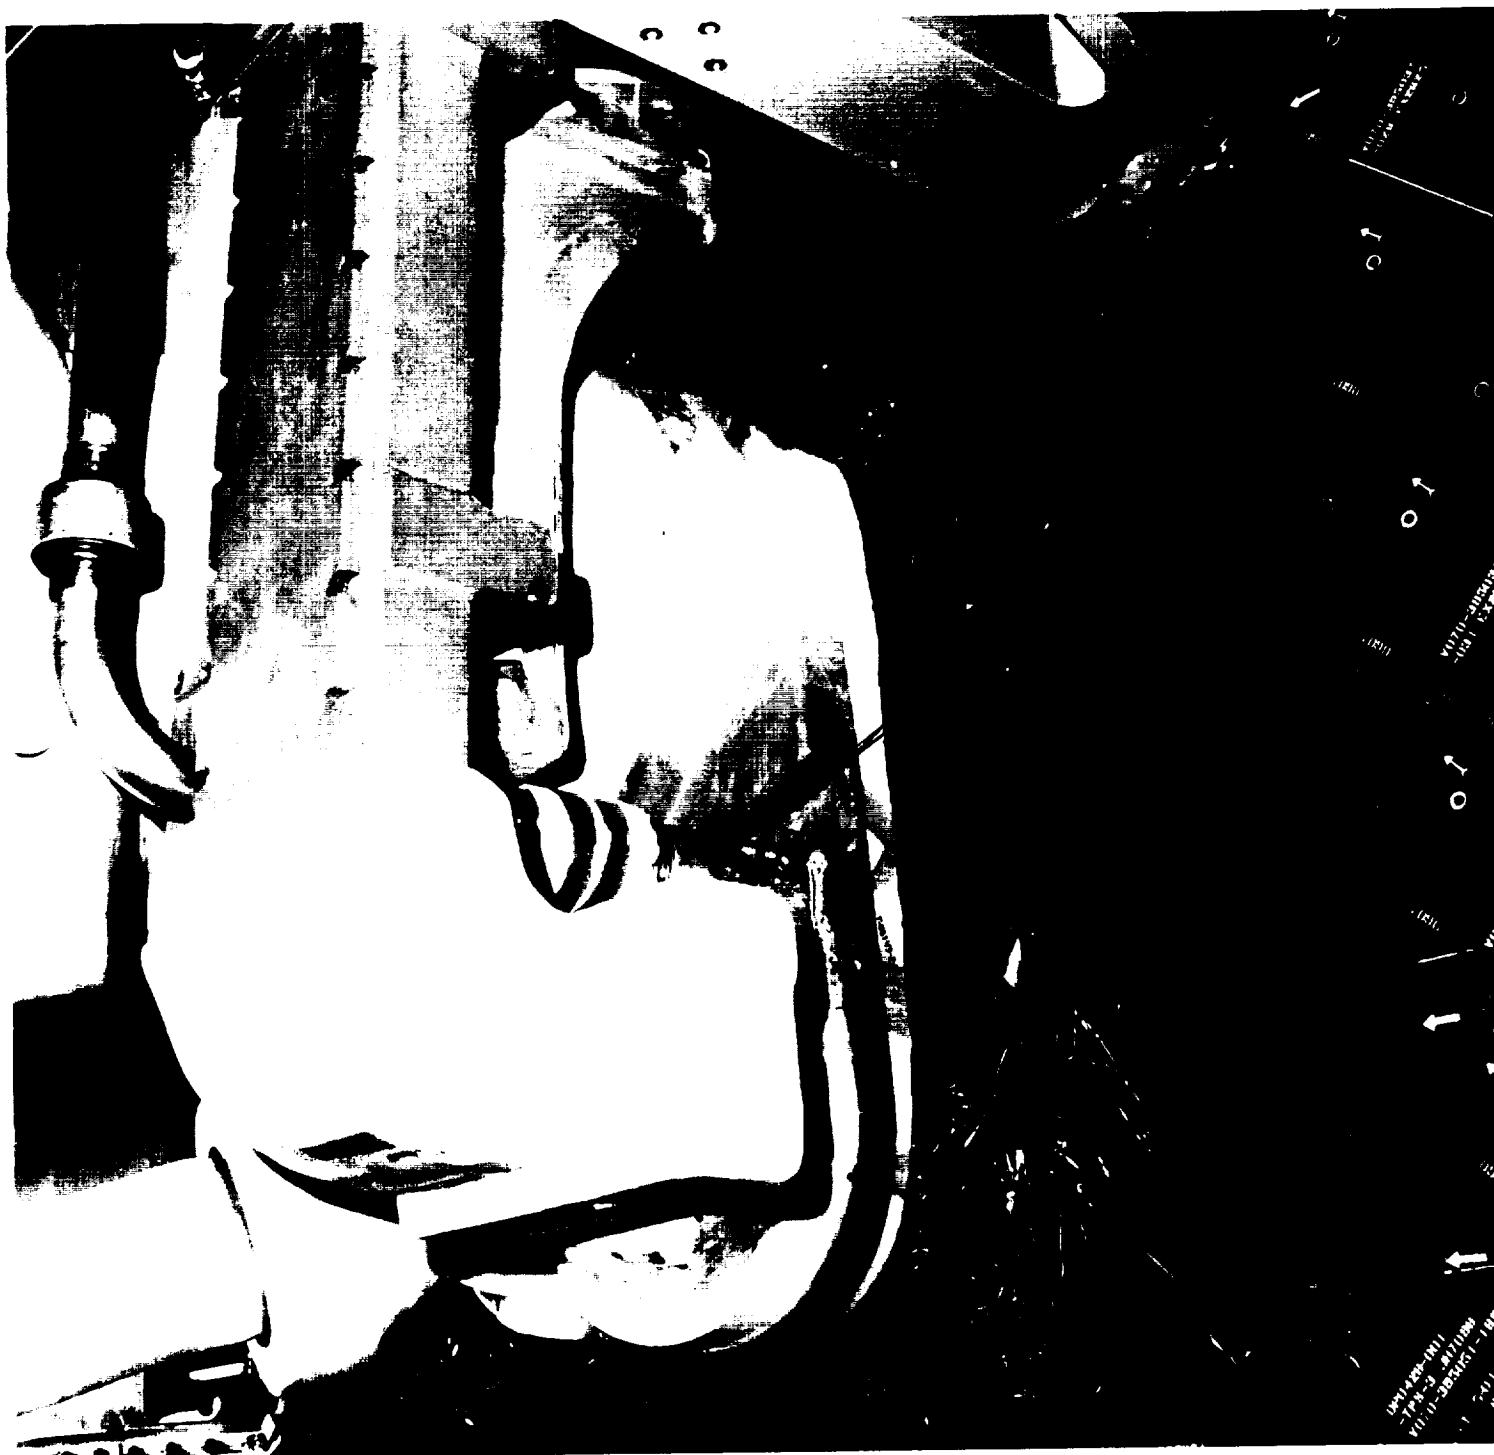
Overall view of LH2 ET/ORB umbilical. Instrumentation on
LH2 pressurization line is for FRF only.

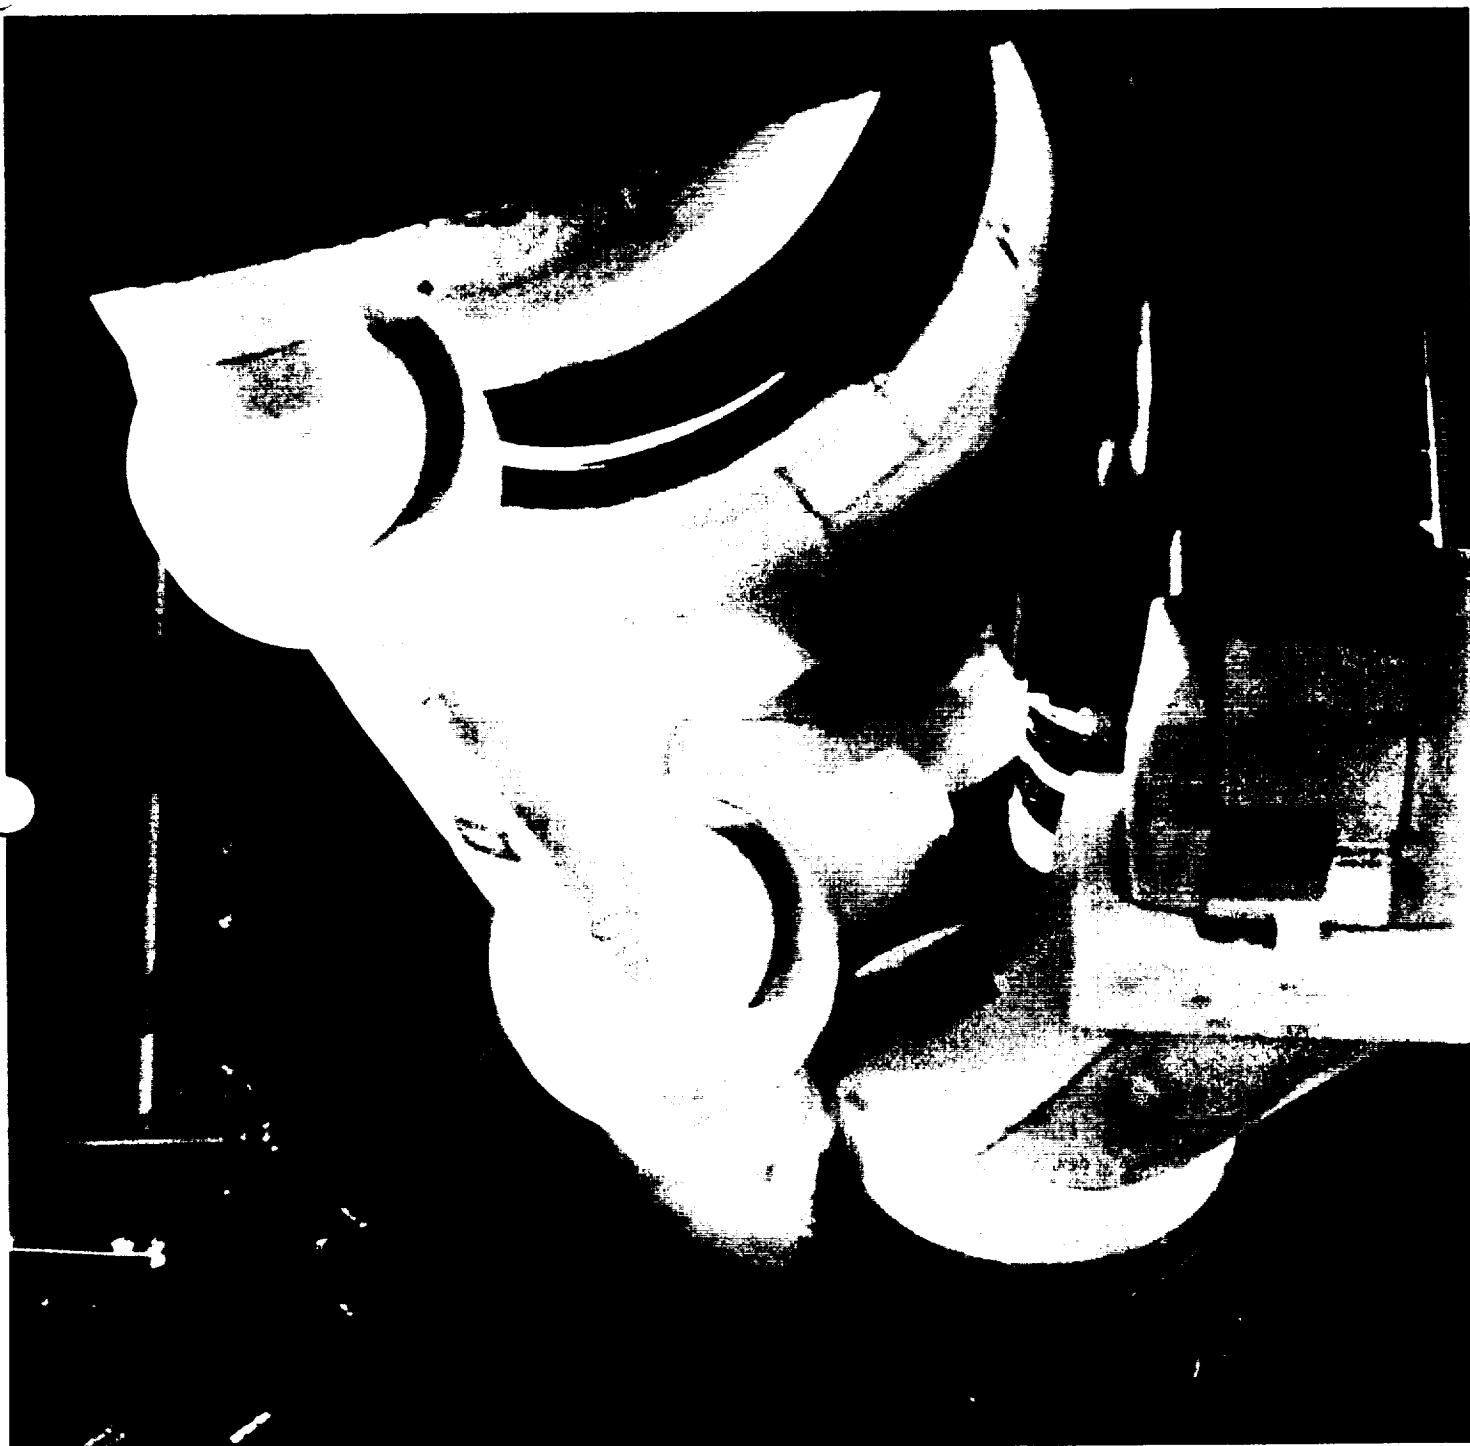
Ice/frost had formed on the thin TPS around the aft pyrotechnic canister closeout and bondline. A 4-inch ice/frost formation with venting (blowing) purge gas was present on the 17-inch flapper valve actuator access port foam plug forward corner.

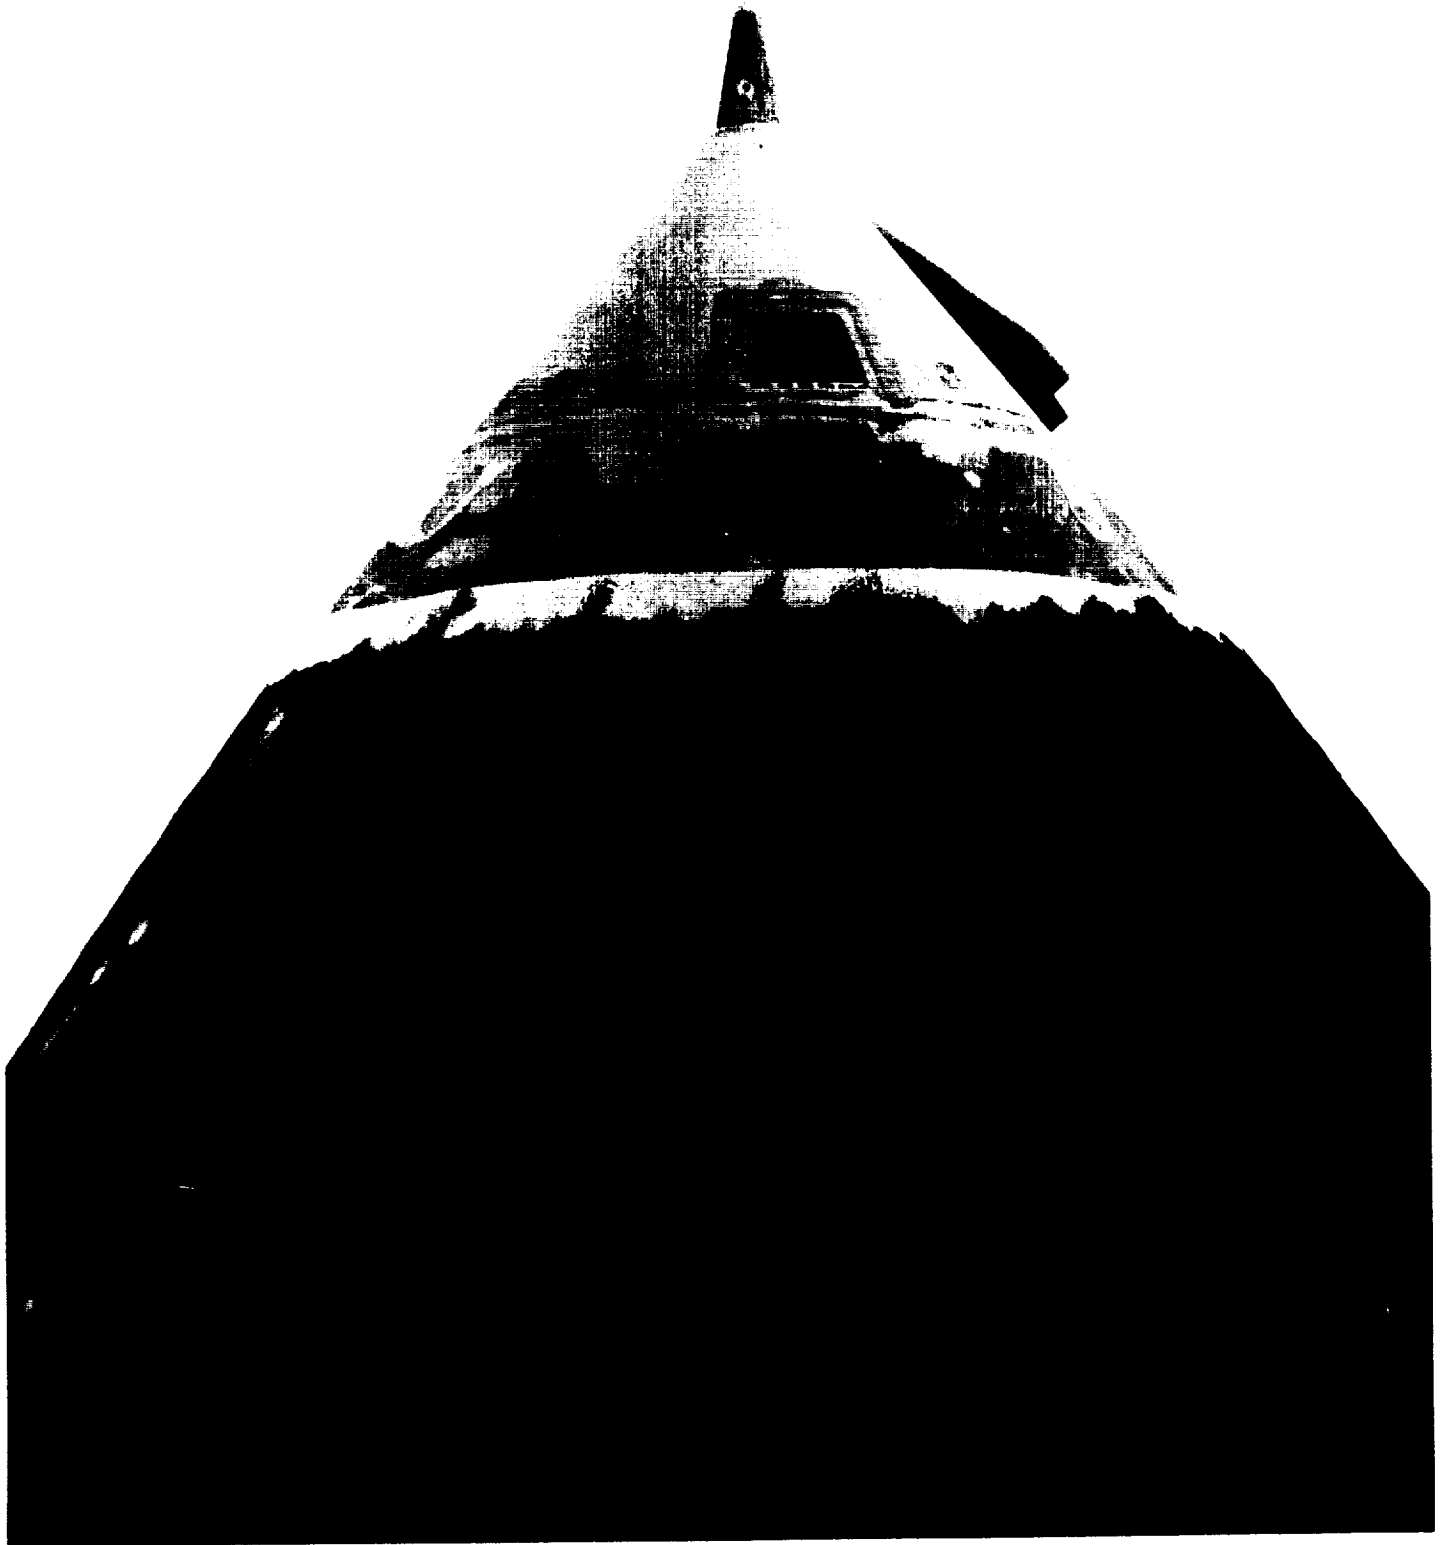
There were no significant anomalies on the nosecone, fairing, and louvers. Five small areas of topcoat were missing near the grid due to chafing from the GOX vent seals.

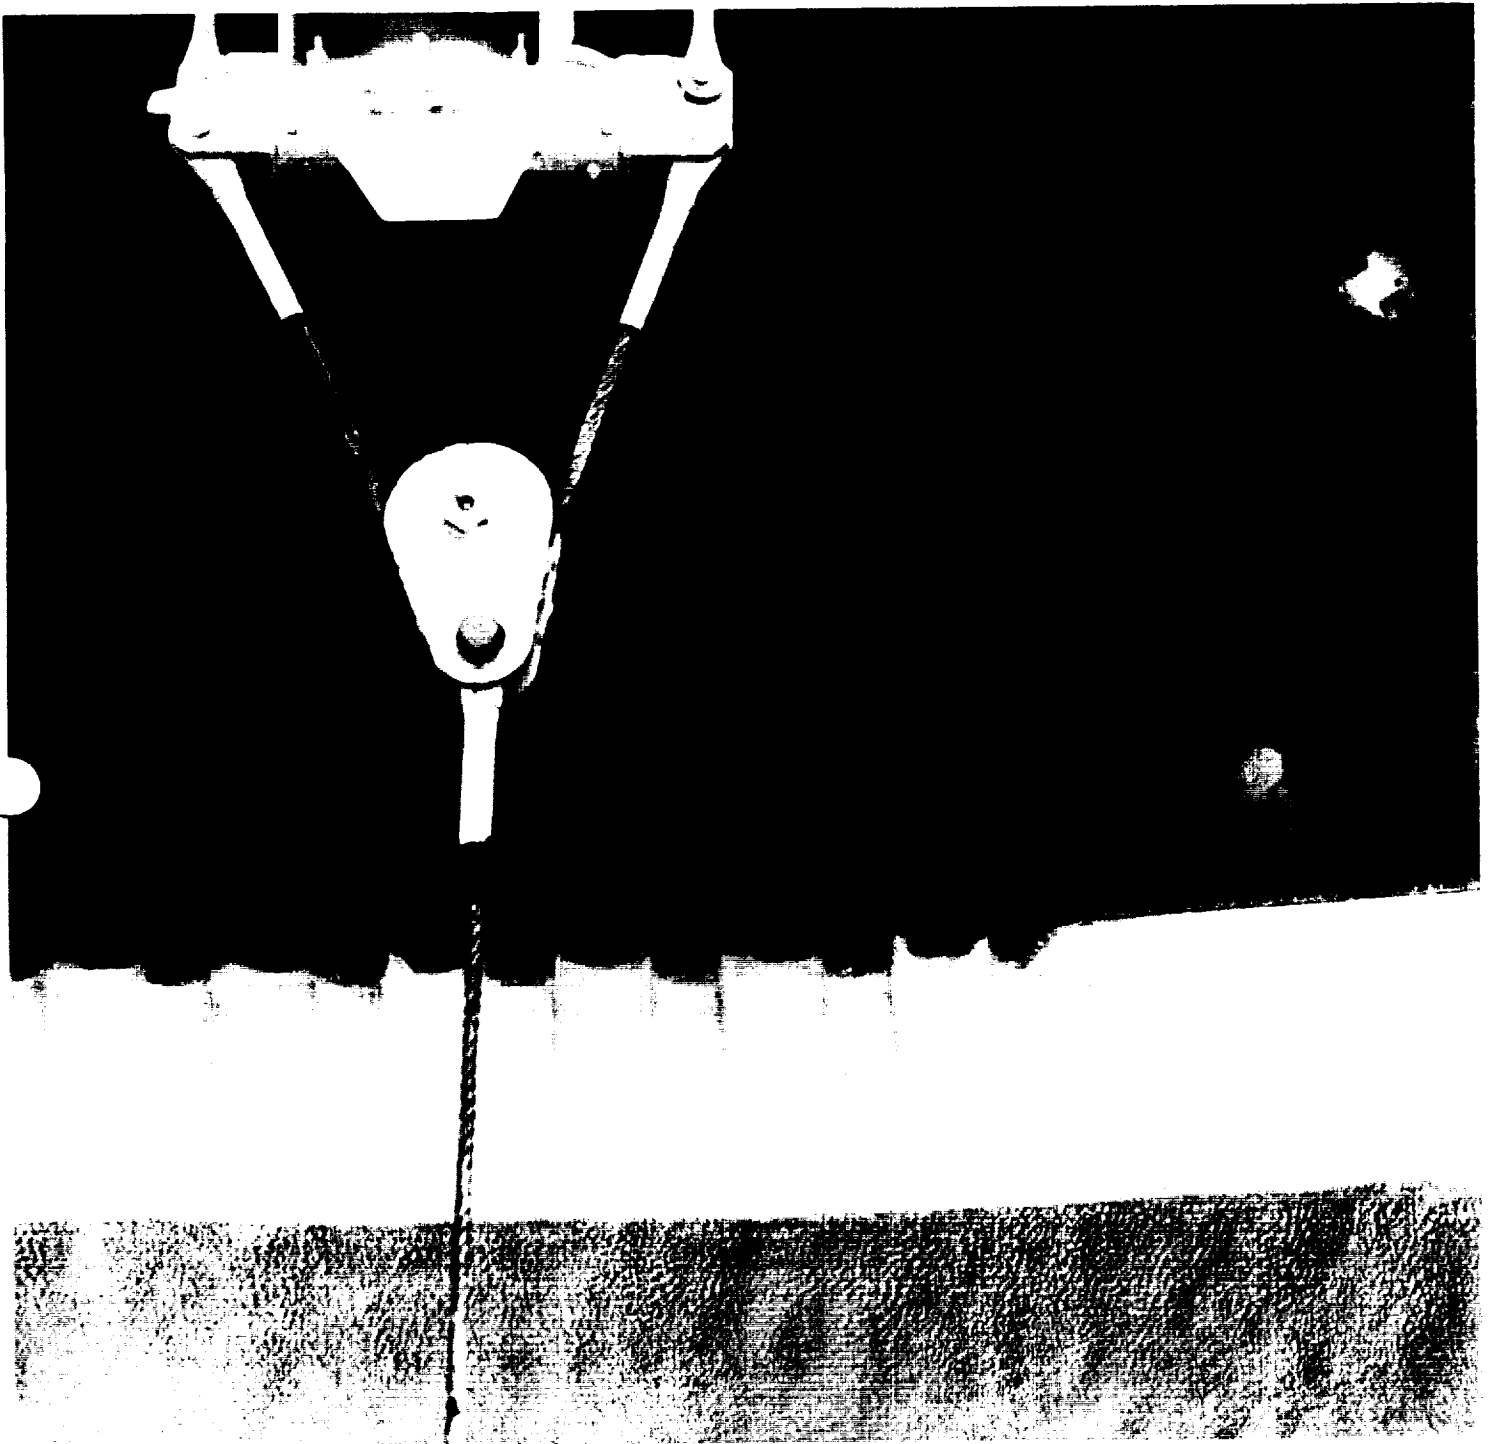
The thermal stress crack that had appeared in the intertank stringer valley adjacent to the thrust panel had closed during tank warm-up and was not visible during the Drain Inspection.

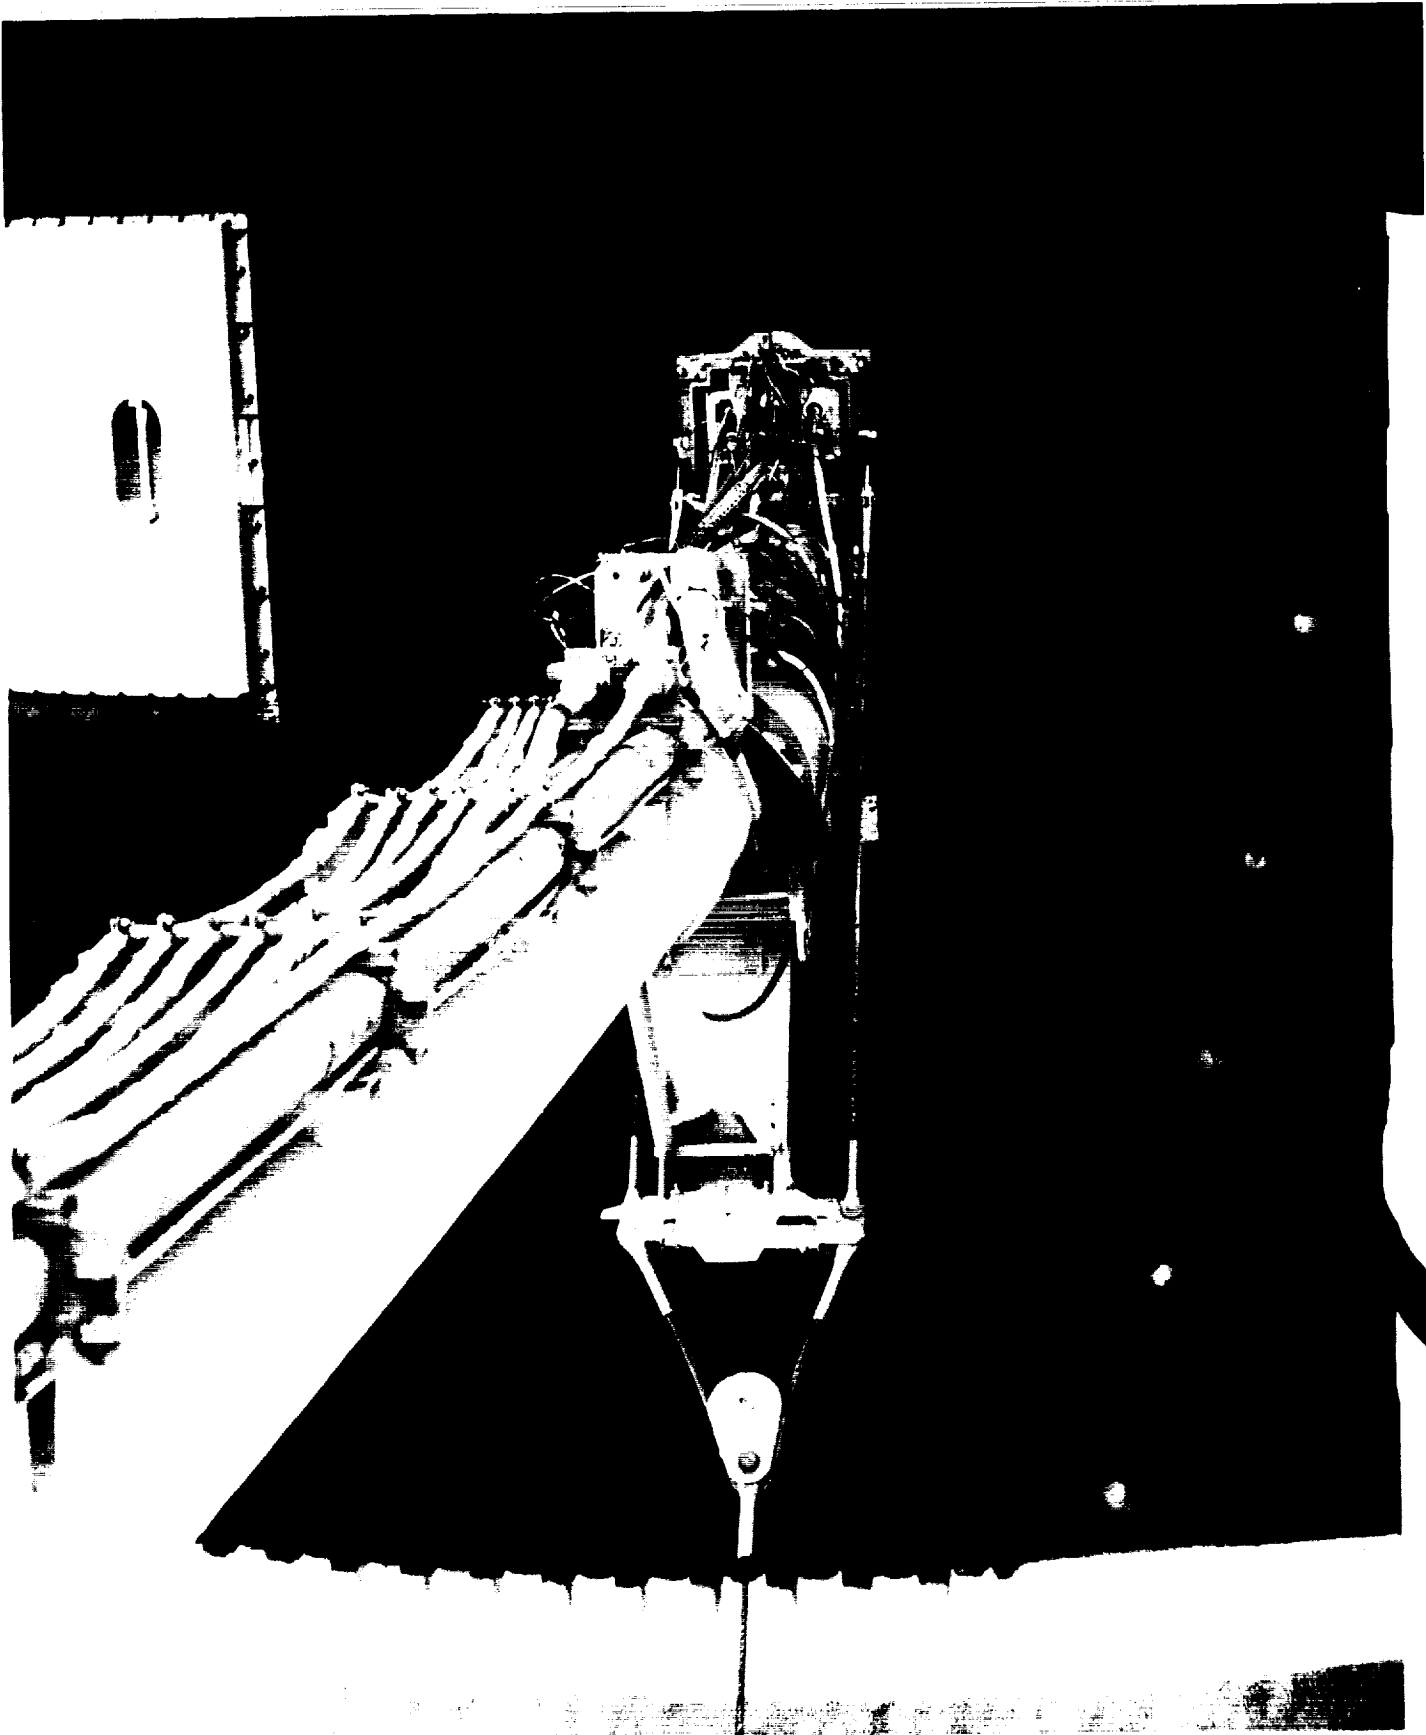
Overall view of the intertank TPS prior to cryogenic loading. A thermal stress crack, which had formed in the first stringer valley adjacent to the thrust panel during the FRF cryogenic loading, had closed up and is not visible when the tank is at ambient temperature.

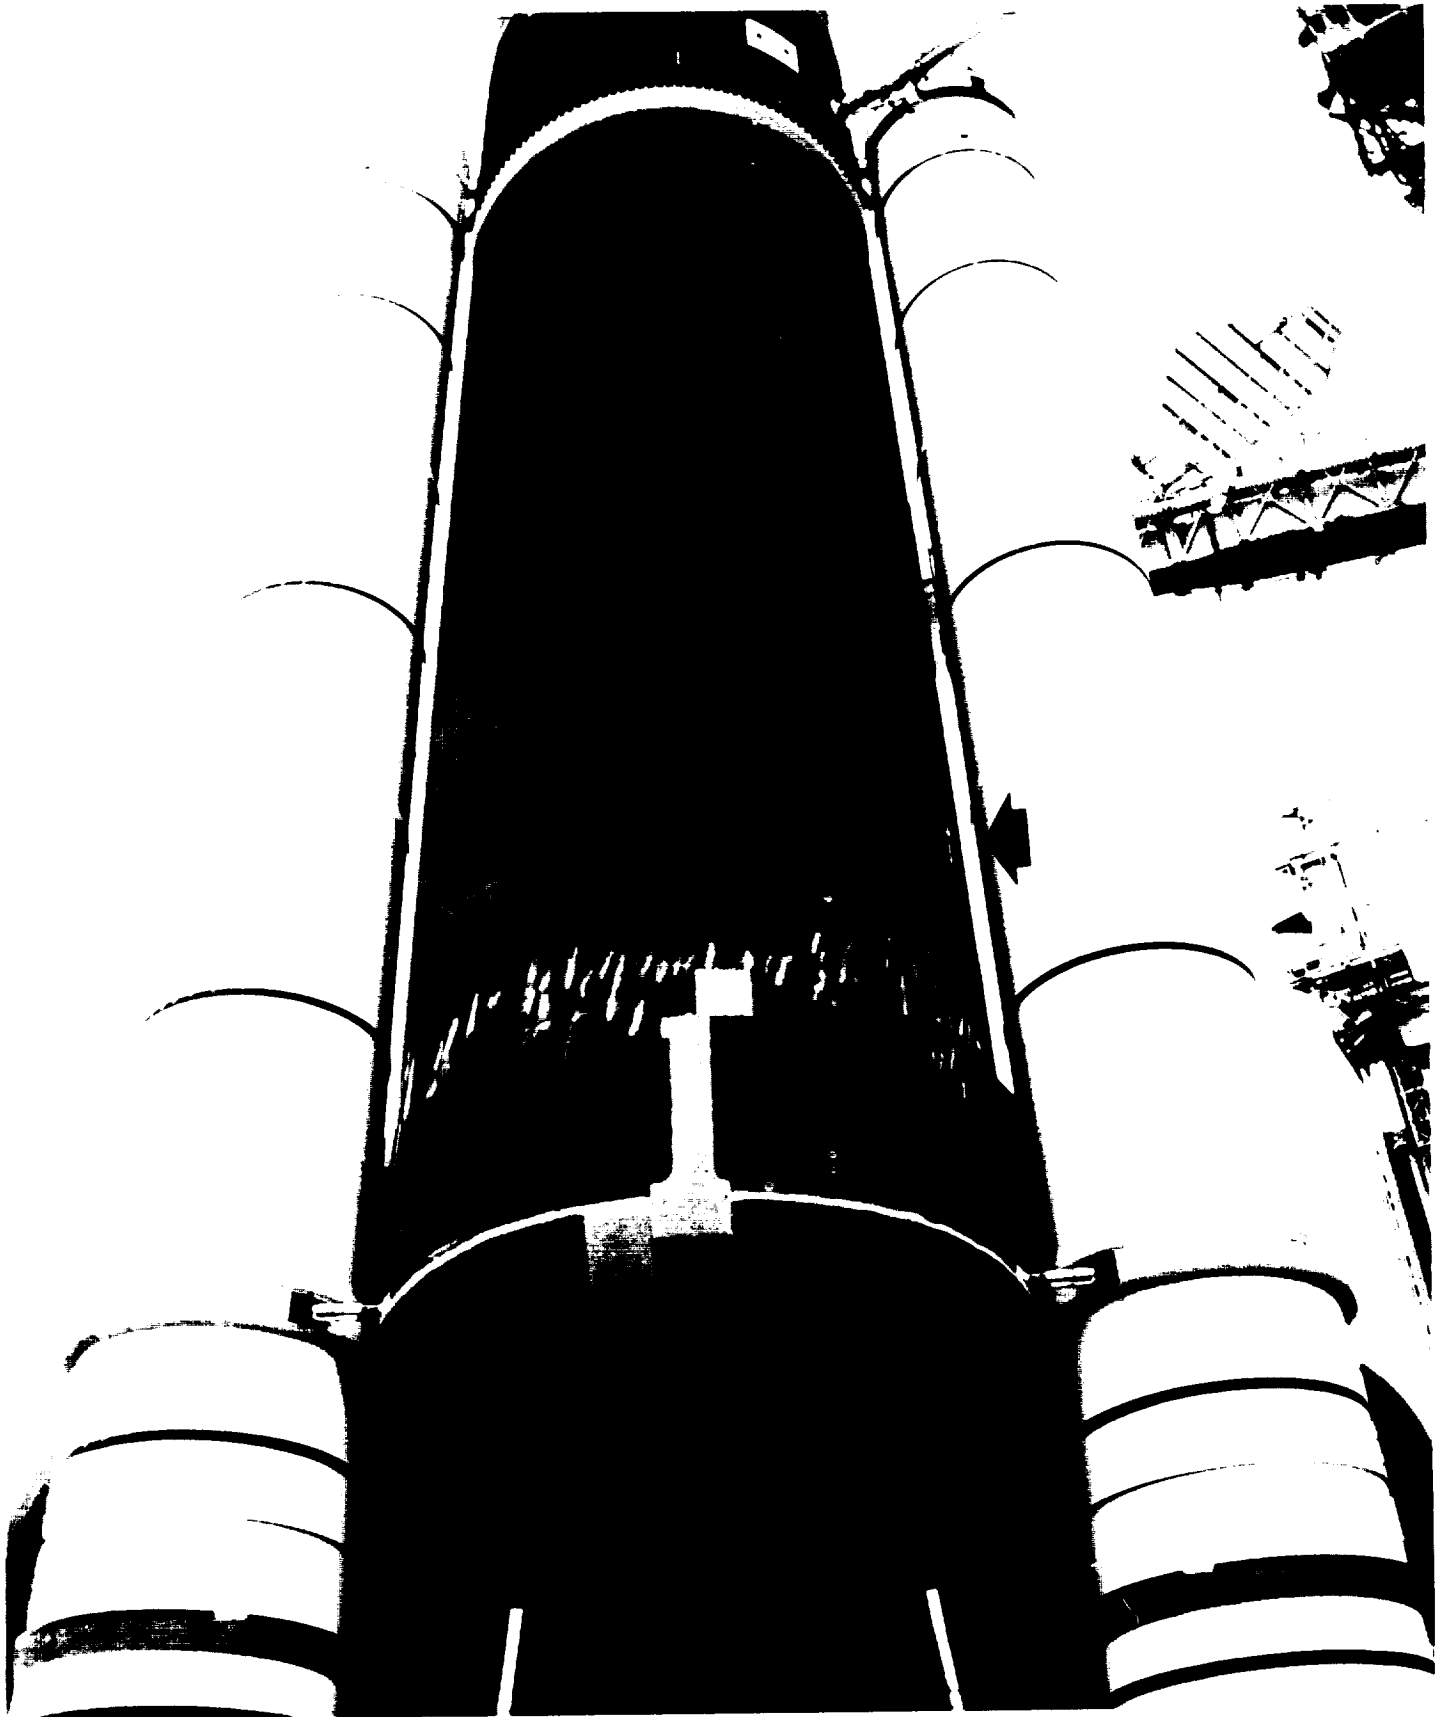
Prior to the Flight Readiness Firing, a piece of rope was observed adhering to the LH2 tank TPS below the GUCP and approximately 85 feet above the MLP deck. Since the rope was on the -Z side and not a debris concern, and would not affect TPS performance, it was not removed prior to launch.

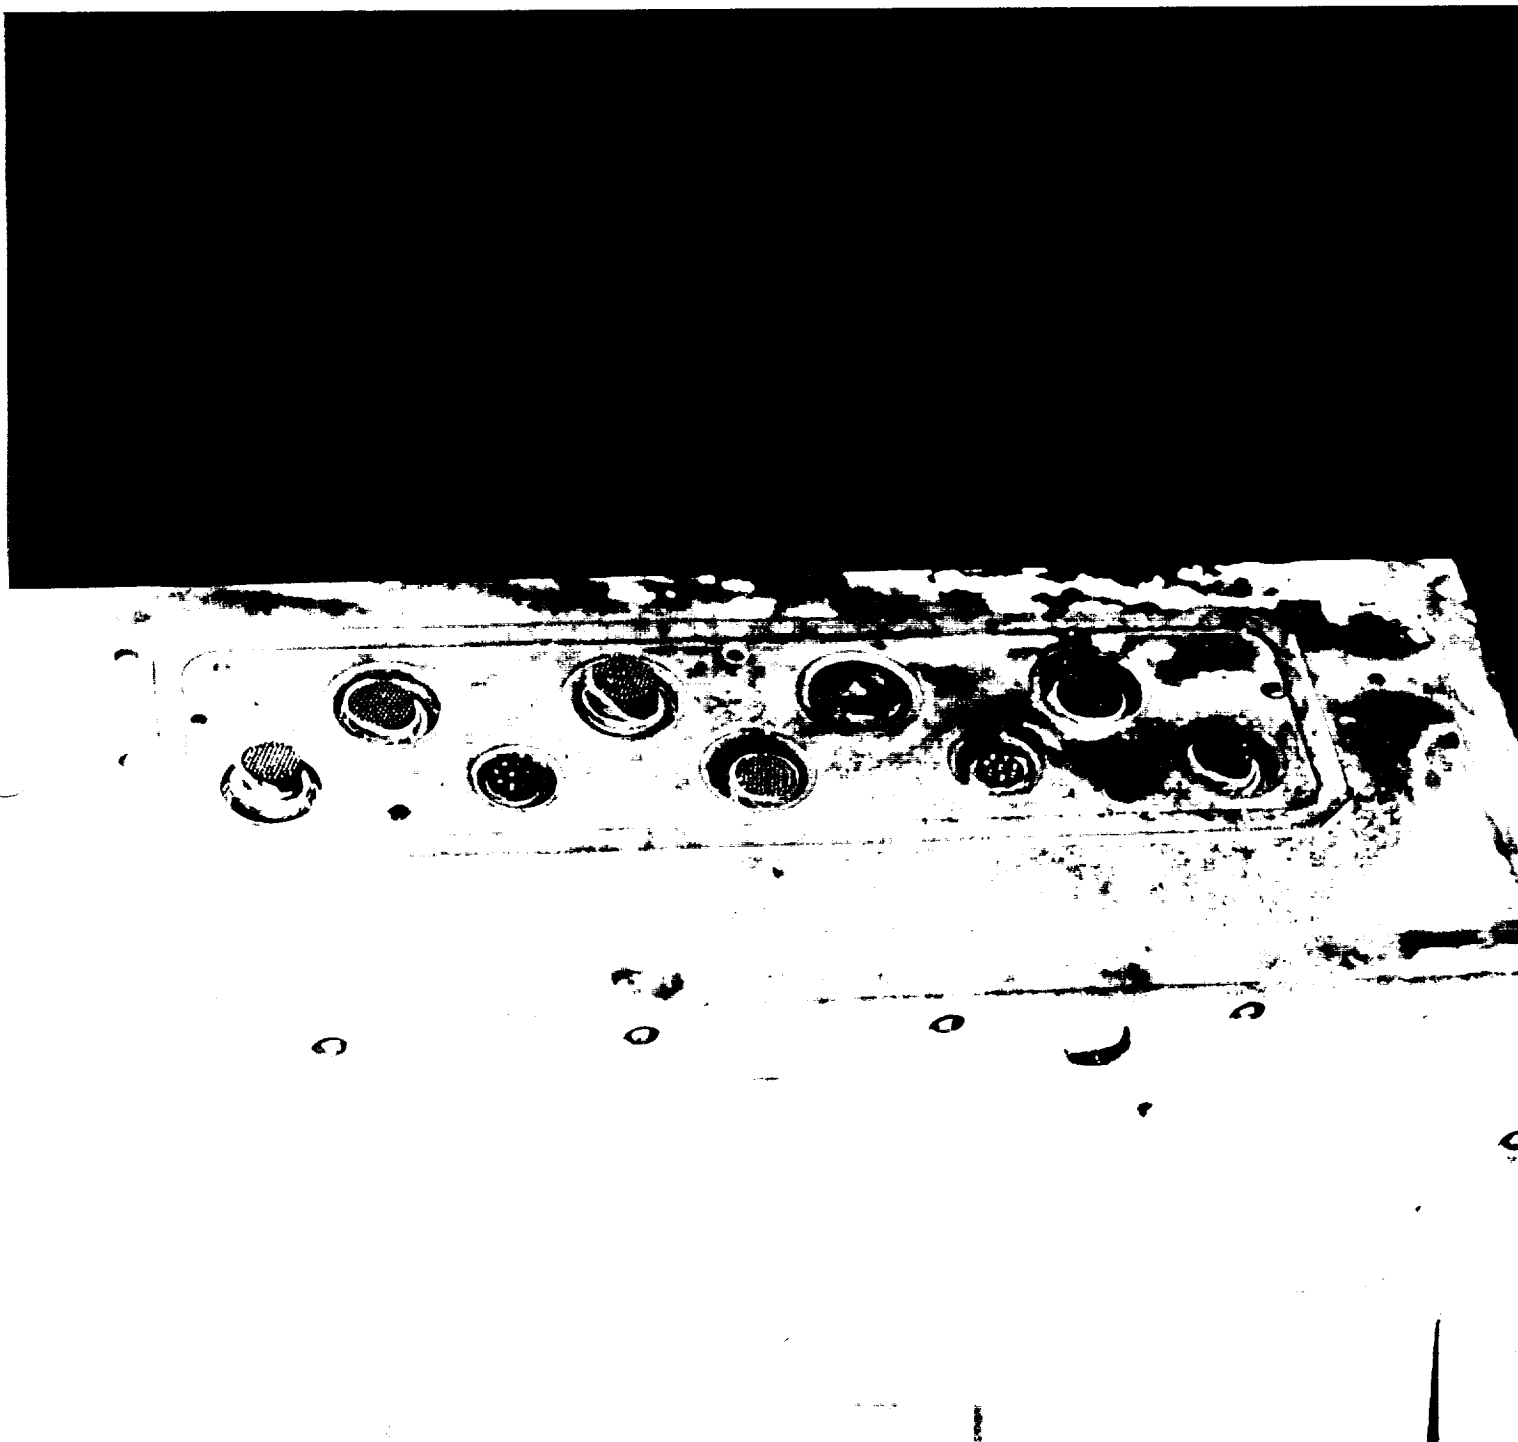
The SRB T-0 umbilicals sustained minor damage

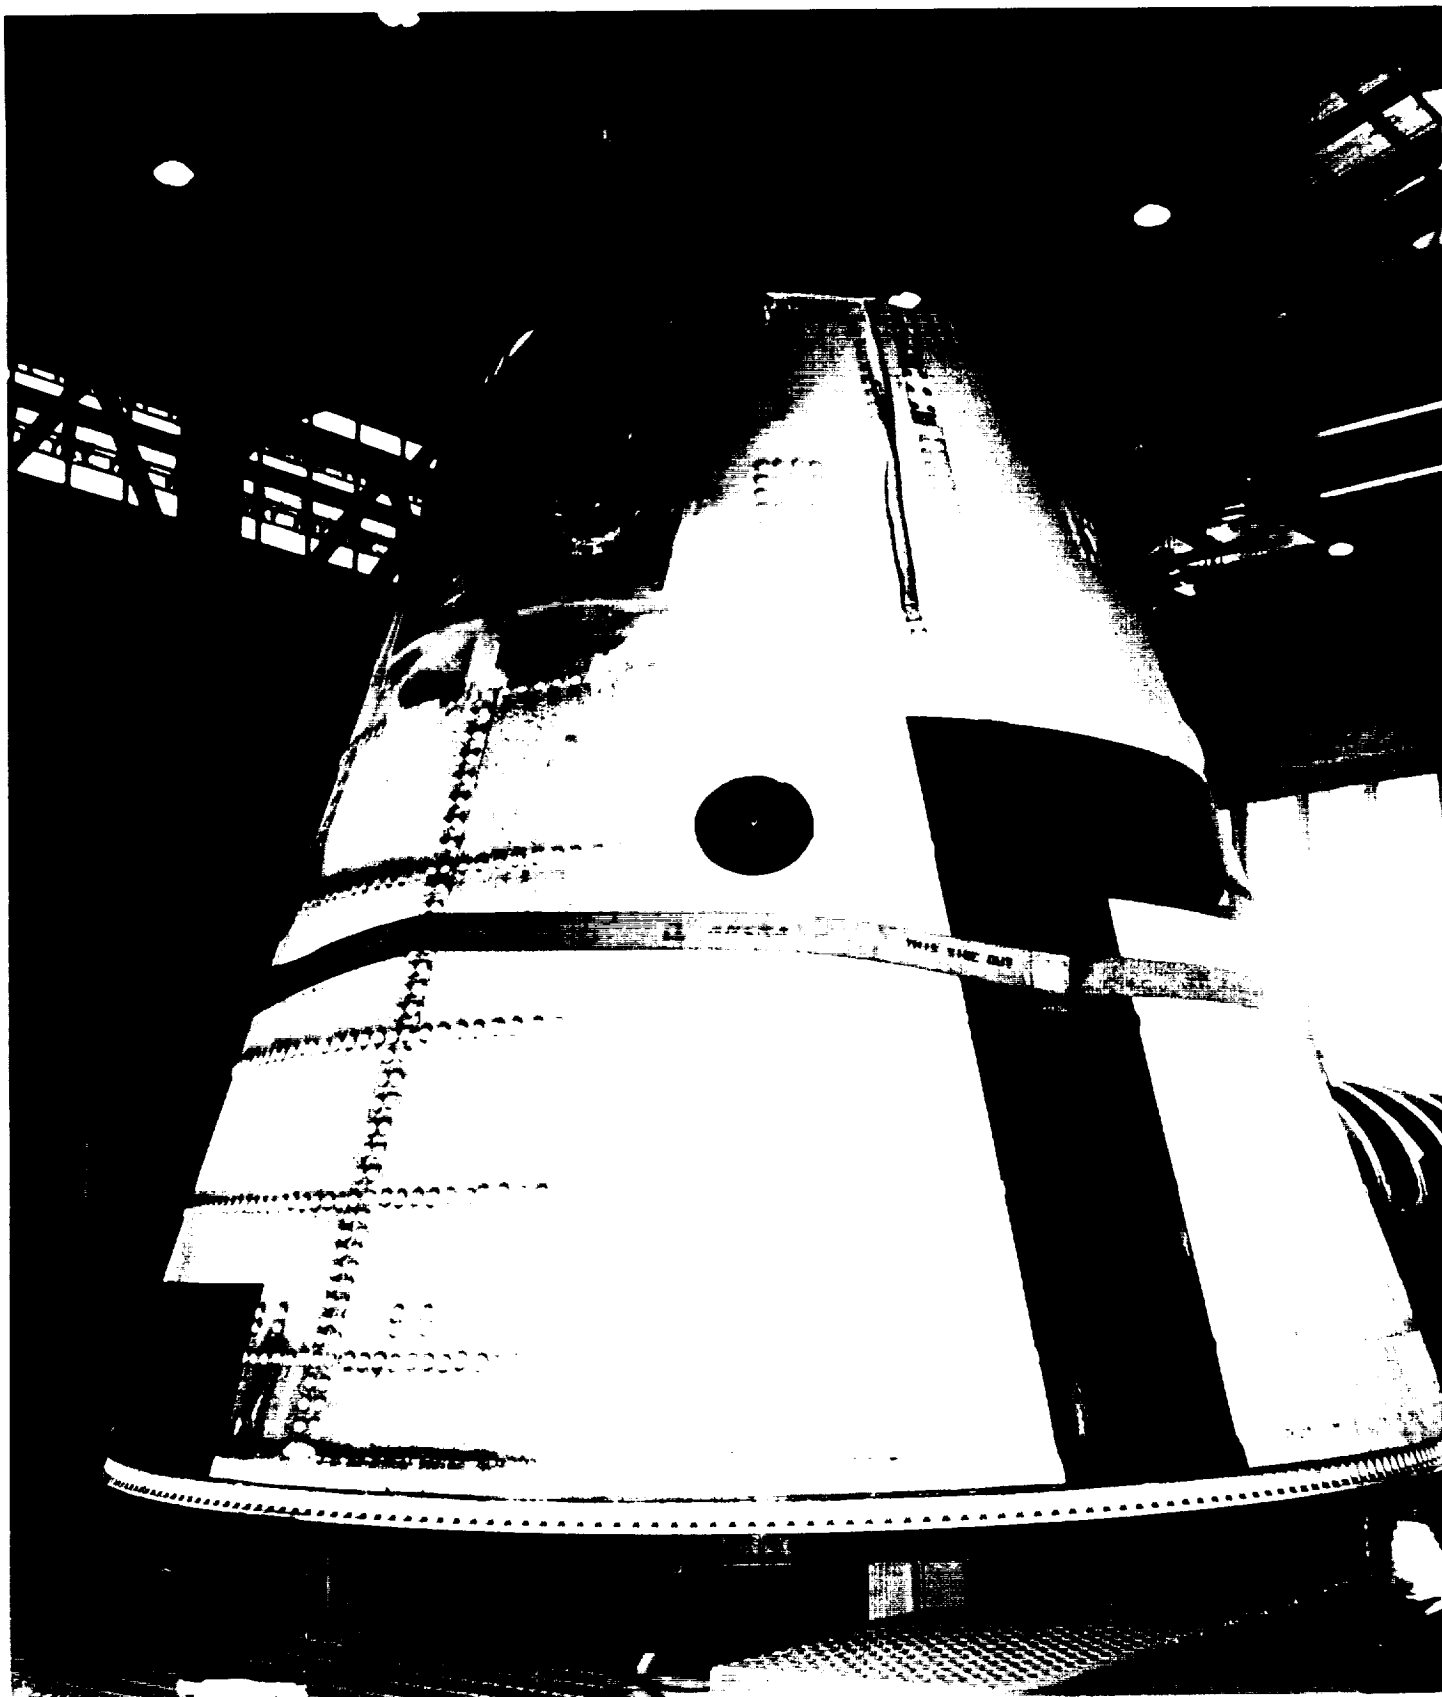
The RH frustum was missing no TPS but had 5 MSA-2 debonds over fasteners. Minor blistering of the Hypalon paint had occurred along the 395 ring. Two (right side) aero heat shield cover attach rings had been bent at the hinge by riser entanglement.

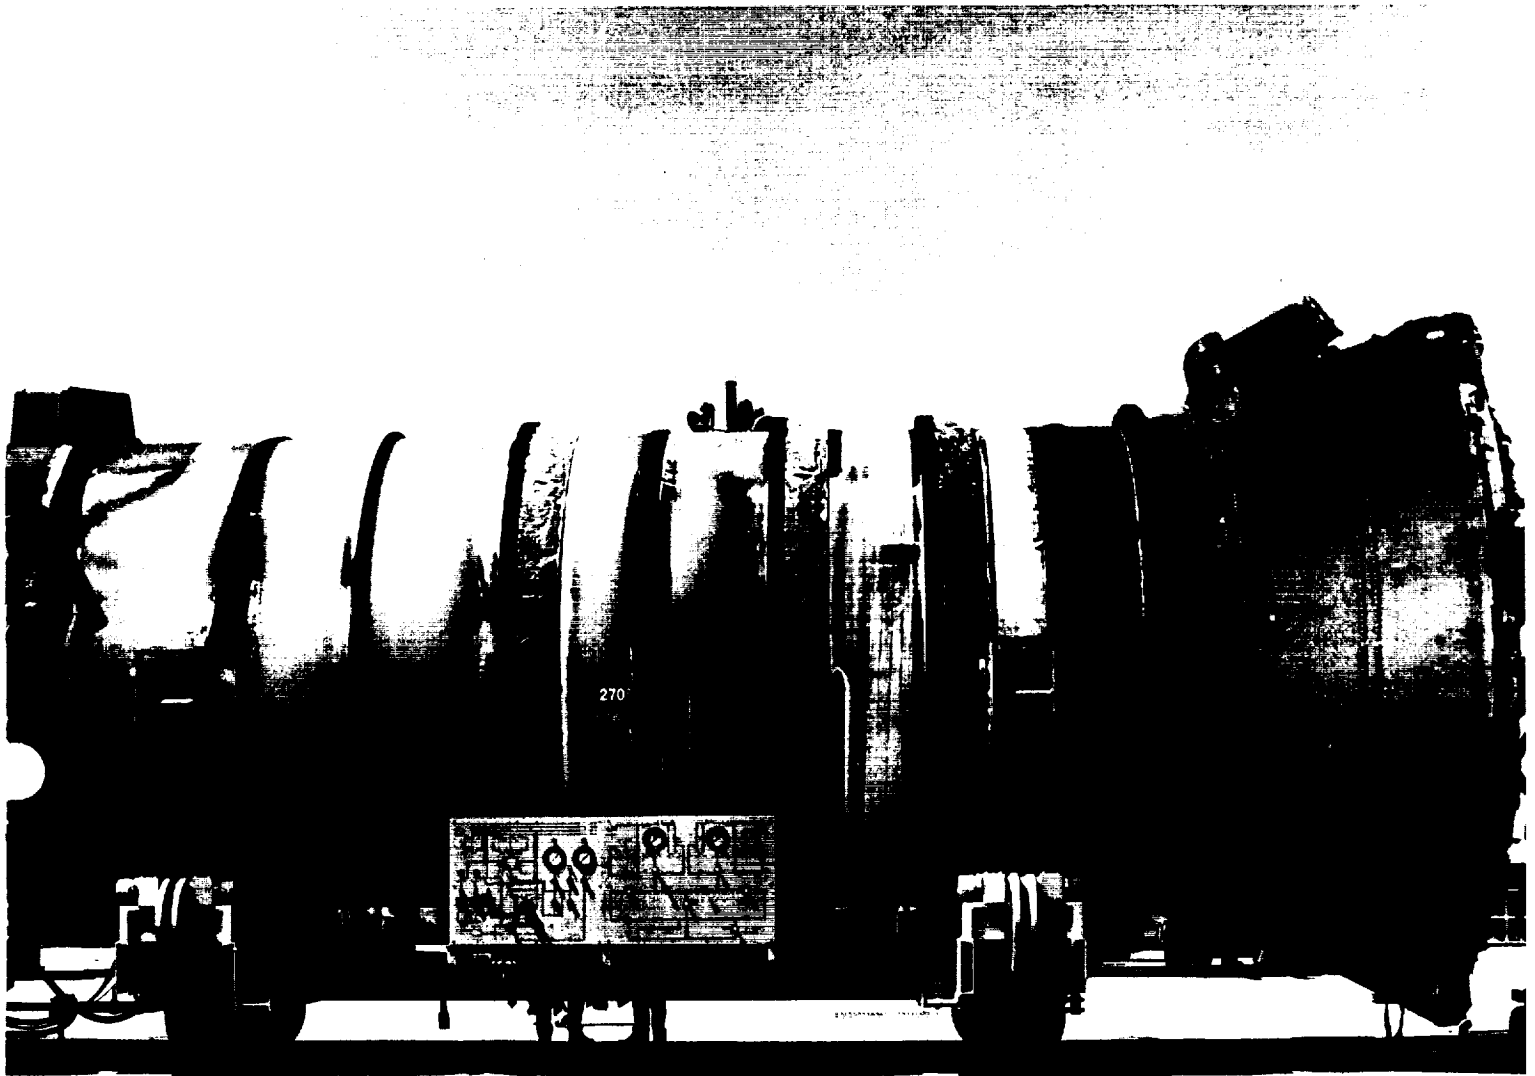
Post flight condition of the RH aft booster. The aft skirt acreage TPS was sooted but in good condition. The ET/SRB aft struts, ETA ring, and IEA appeared undamaged. All three aft booster stiffener rings sustained water impact damage.

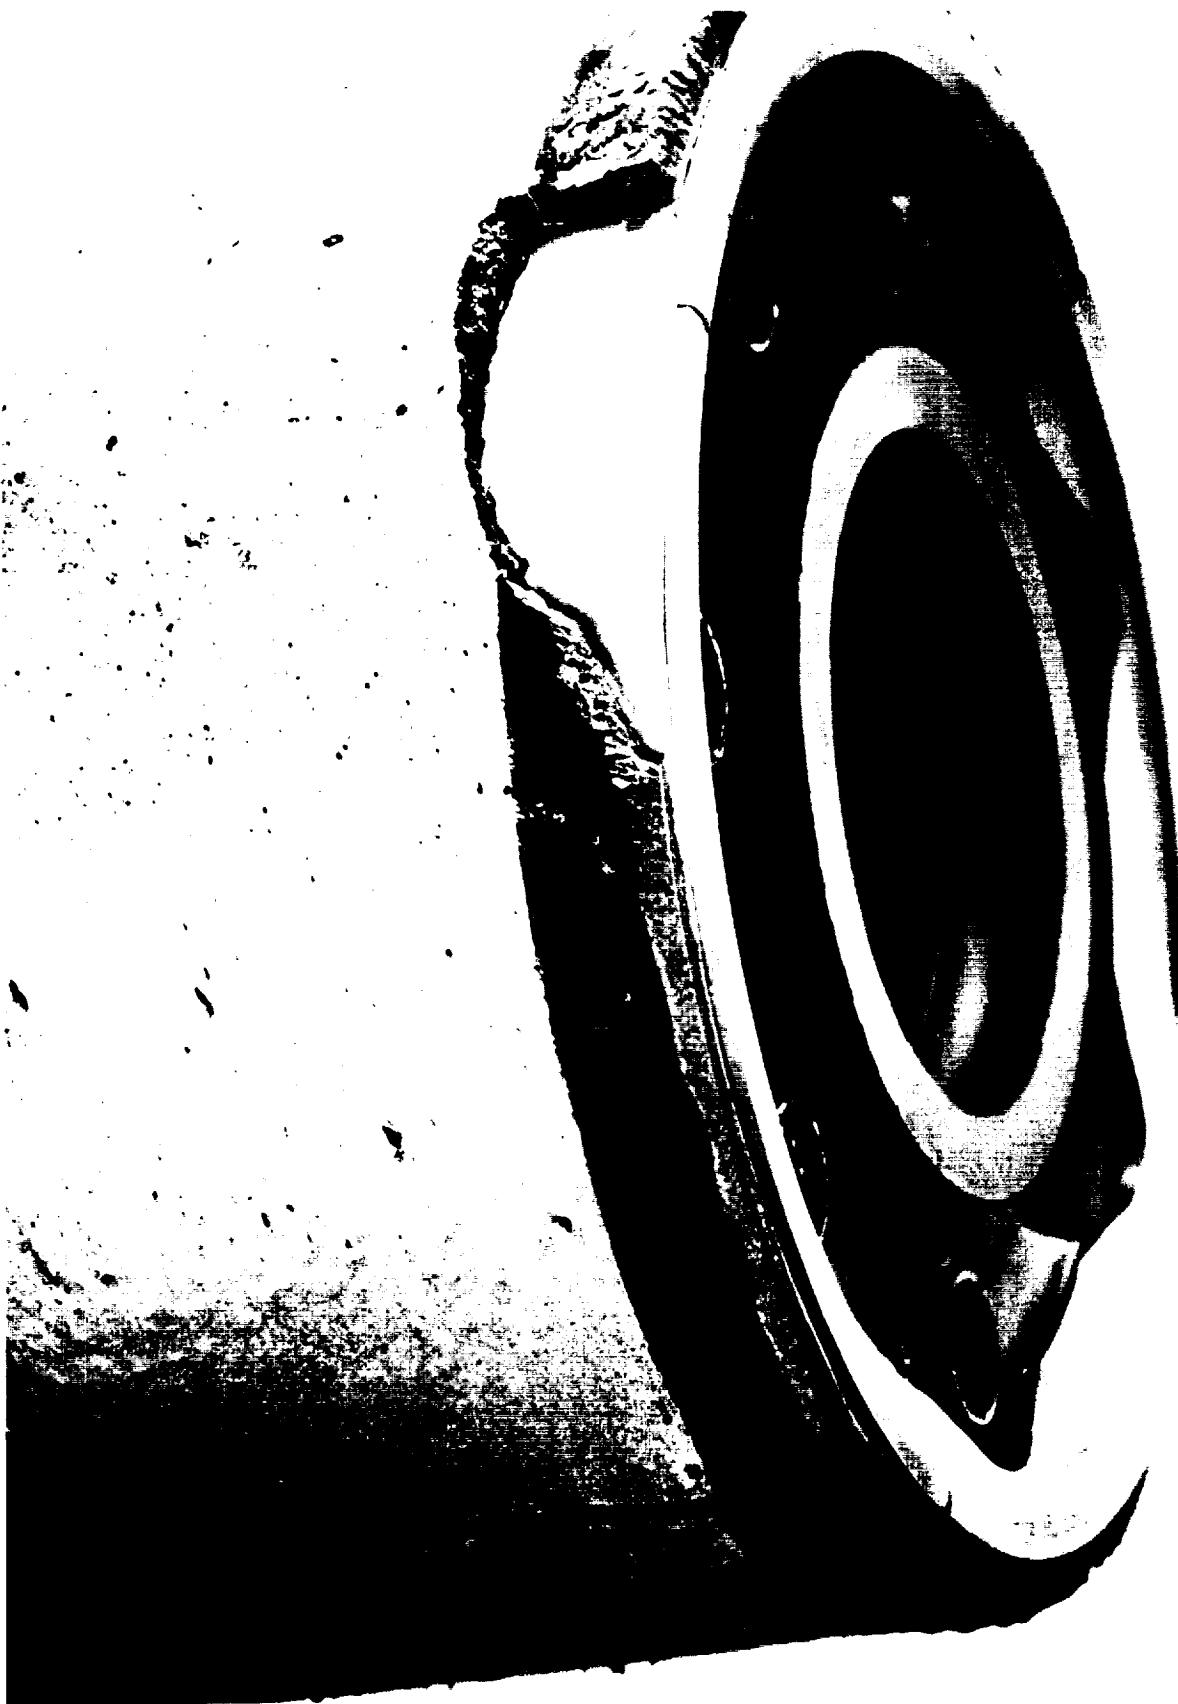
A 5"x1.5" area of TPS on the forward side of the upper strut fairing at the separation plane was missing but the substrate was not charred. The loss of TPS may have occurred during strut separation.
